## SPACE STATION WP-2 APPLICATION OF LDEF MLI RESULTS

## SUMMARY

The Cascaded Variable Conductance Heat Pipe Experiment, which was developed by Michael Grote of McDonnell Douglas Electronic Systems Company, was located in Tray F-9 of the Long Duration Exposure Facility (LDEF), where it received atomic oxygen almost normal to its surface. The majority of the tray was covered by aluminized Kapton® polyimide multilayer insulation (MLI), which showed substantial changes from atomic oxygen erosion. Most of the outermost Kapton layer of the MLI and the polyester scrim cloth under it were lost, and there was evidence of contaminant deposition which discolored the edges of the MLI blanket. Micrometeoroid and orbital debris (MM/OD) hits caused small rips in the MLI layers, and in some cases left cloudy areas where the vapor plume caused by a hit condensed on the next layer. The MLI was bent gradually through 90° at the edges to enclose the experiment, and the Kapton that survived along the curved portion showed the effects of atomic oxygen erosion at oblique angles. In spite of space environment effects over the period of the LDEF mission, the MLI blanket remained functional.

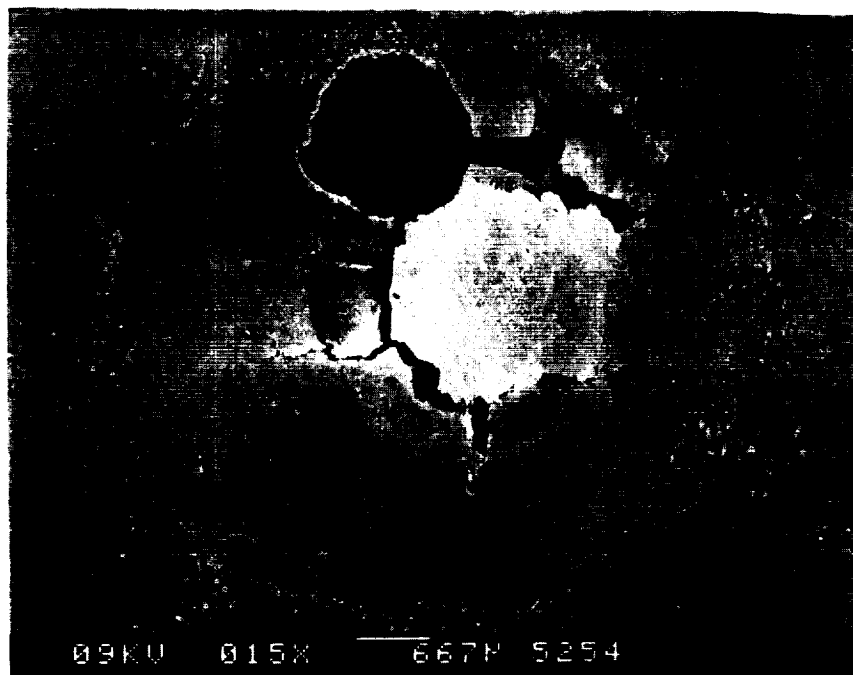
Figure 1. Debris impact area of second Kapton layer, SEM,  $\times 15$ .

Meteoroid and debris hits caused small penetrations and rips in the MLI layers, and in some cases left cloudy areas where the vapor plume caused by a hit condensed on the next layer. An example of this is shown in Figures 1 to 7. A particle struck the 0.076-mm (0.003-in) thick outer layer of the MLI before that layer was completely eroded away by the atomic oxygen, and it produced a debris plume which hit the next 0.0076-mm (0.0003-in) thick Kapton layer, causing rips and perforations. These are shown in Figures 1 to 3. Most of the plume was stopped by the first 0.0076-mm (0.0003-in) layer, and the only place where the plume reached the second 0.0076-mm (0.0003-in) layer was at the vent hole, where the impact of the plume ripped and perforated it. Figure 4 shows the vent hole and the impact area, with the shadow of the scrim cloth. Figures 5 to 7 show higher magnifications of the impact area and of the rips and perforations caused by the debris plume.

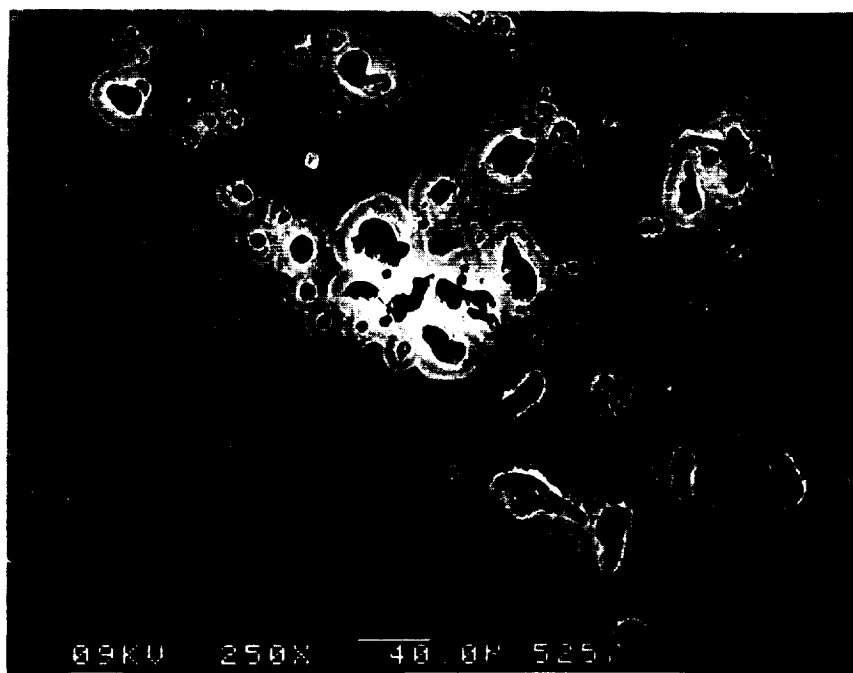
Figure 2. Debris impact area of second Kapton layer, showing perforations, SEM,  $\times 250$ .

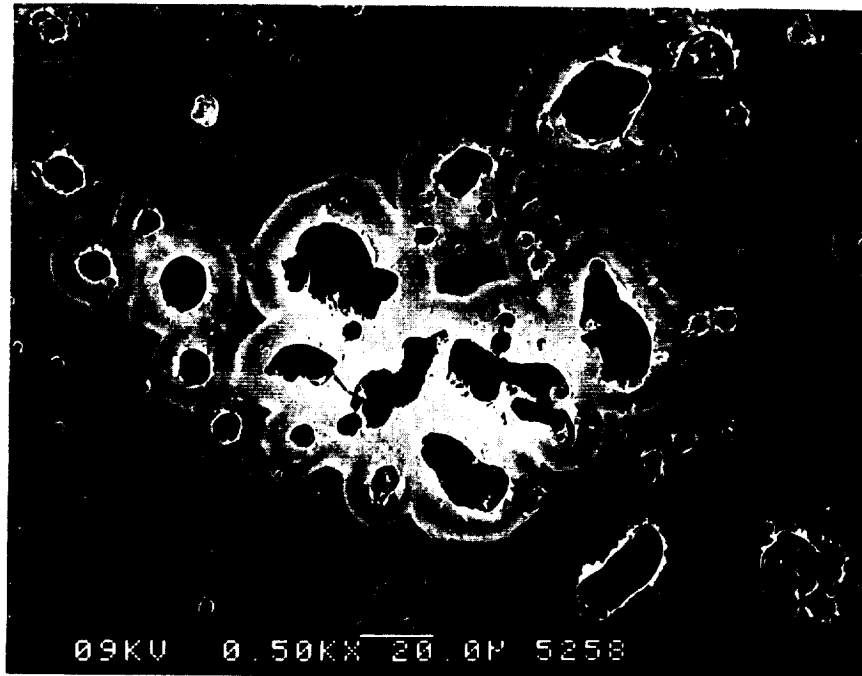
Figure 3. Debris impact area of second Kapton layer, showing undercutting, SEM,  $\times 500$ .

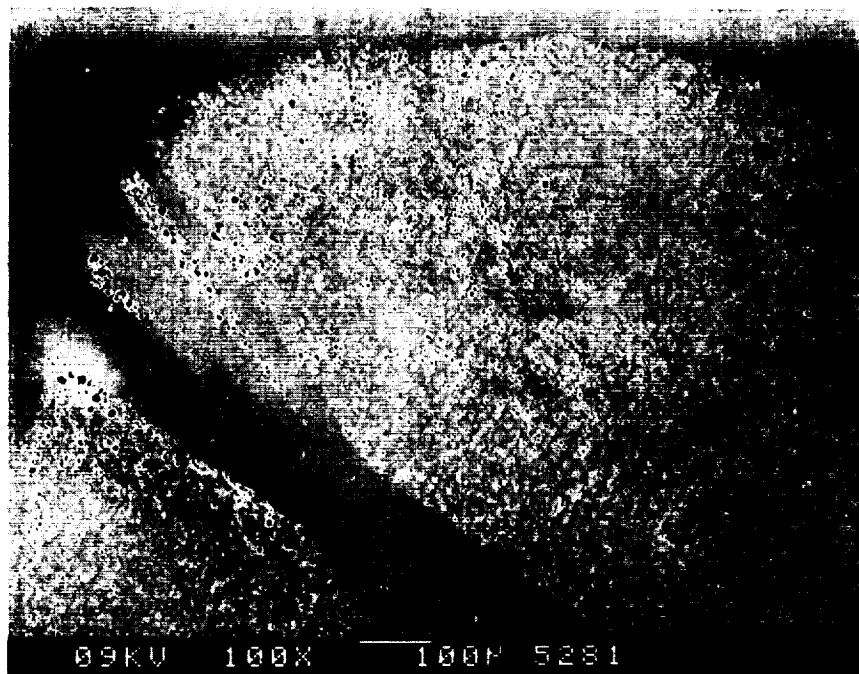
Figure 5. Same area of third Kapton layer, SEM,  $\times 100$ .

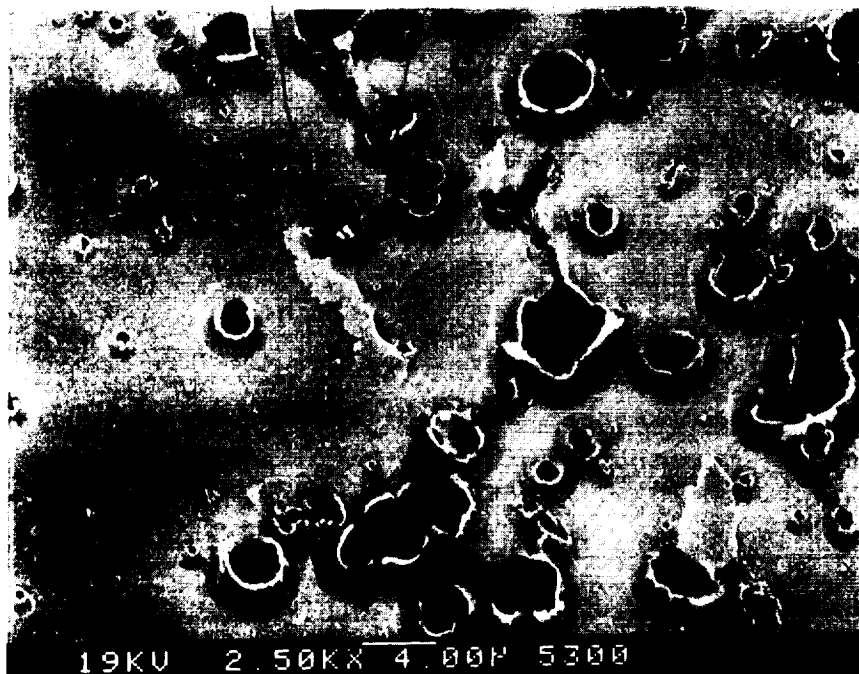
Figure 7. Third Kapton layer, showing a small particle with high titanium, possibly paint, SEM,  $\times 2,500$ .

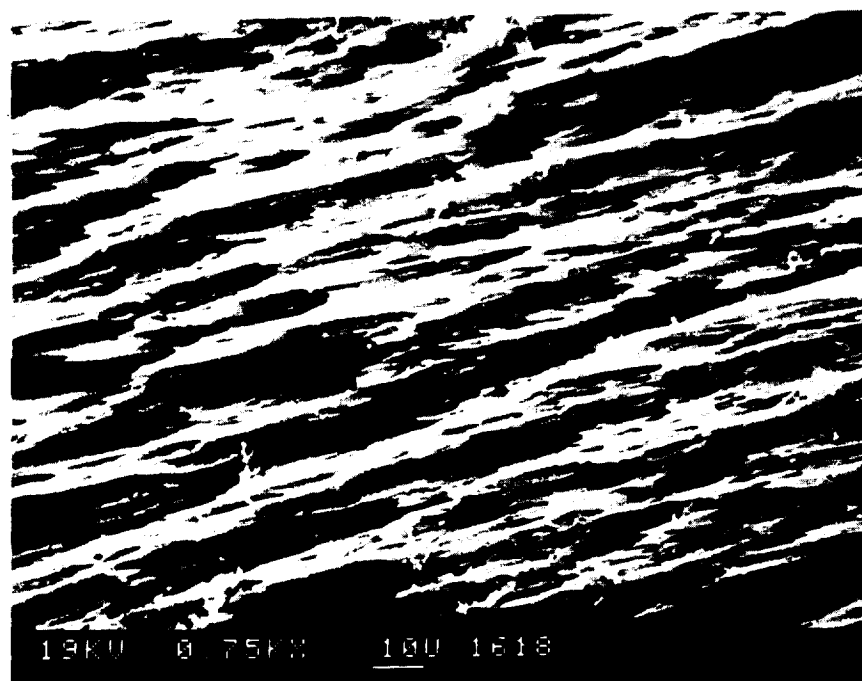
Figure 8. SEM photograph of the aluminized Kapton lightblock exposed to AO at a very oblique angle, SEM,  $\times 750$ .

Because the MLI was bent gradually through 90° at the edges in order to attach it to the Velcro strips on the side of the tray, the Kapton which survived along the curved portion showed the effects of atomic oxygen erosion at oblique angles, as shown in the scanning electron microscope photograph, Figure 8.

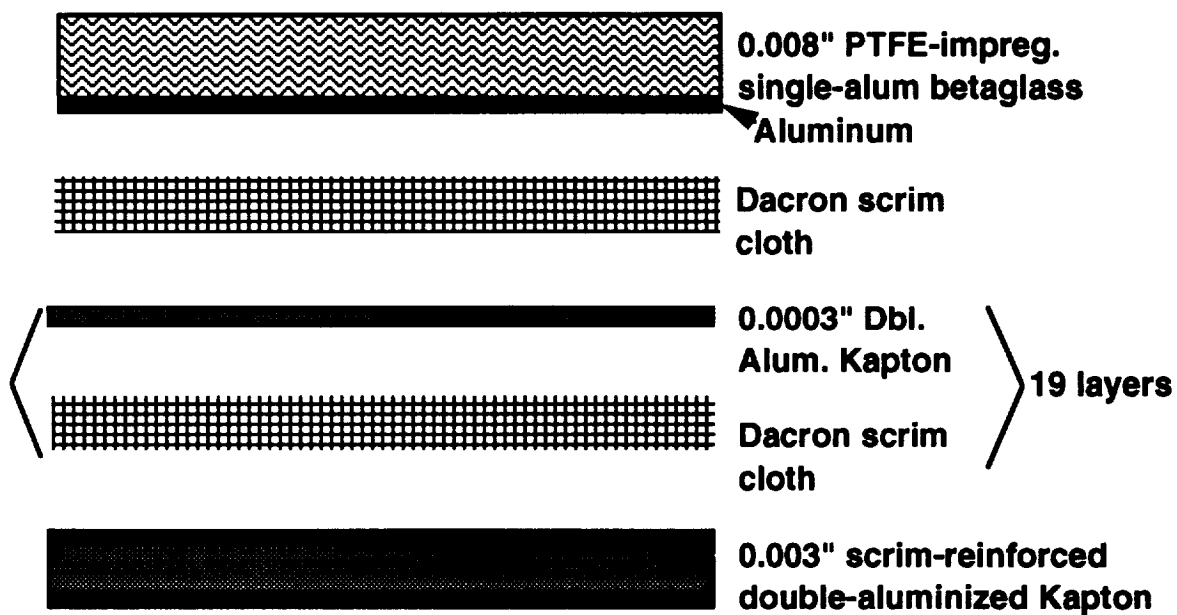
Figure 9. Layers of the space station MLI blanket and their arrangement.

MDA has developed an MLI blanket design which is expected to be compatible for 30 years in the S.S. *Freedom* LEO. This design is based on our understanding of material interactions which we gained from the LDEF experiment and from thermal system requirements. The blanket includes a 0.2-mm (0.008-in) thick polytetrafluoro-ethylene (PTFE) impregnated, single aluminized Beta™ glass cloth with the aluminized side facing inward, 20 layers of a light weight separator scrim alternating with 19 layers of a 0.008-mm (0.0003-in) double aluminized polyimide film, and a 0.076-mm (0.003-in) thick scrim reinforced double aluminized polyimide. The general blanket layout is shown in Figure 9.
